## Integrated System and Proof of Concept of X-ray Phase Contrast Imaging for Inspection of Composite Materials

The European project EVITA aims at bringing Grating-based Phase Contrast X-ray imaging technology<sup>[1]</sup> to non-destructive evaluation and inspection of thick aeronautical composite structures. The demonstrator built within the project started operation in January 2015. The results confirm the high expectations on the applicability of this technology to the detection of critical defects in composite components such as cracks, porosity, missing plies and fiber waviness. Other industries (automotive, electronics or luxury) are also showing sign of interest.

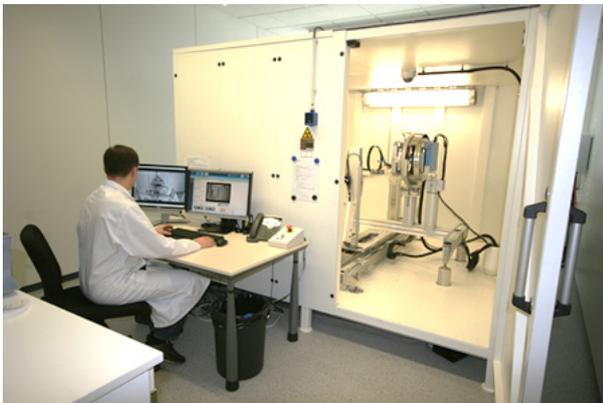
Figure 1: Picture of the EVITA demonstrator at CSEM in Alpnach.

The demonstrator built within the project is depicted in Figure 1. The Phase Contrast X-ray imaging system is enclosed in a radiation protection cabinet to ensure the user safety. The measurement and the reconstruction of the images can be done entirely from the remote control desk.

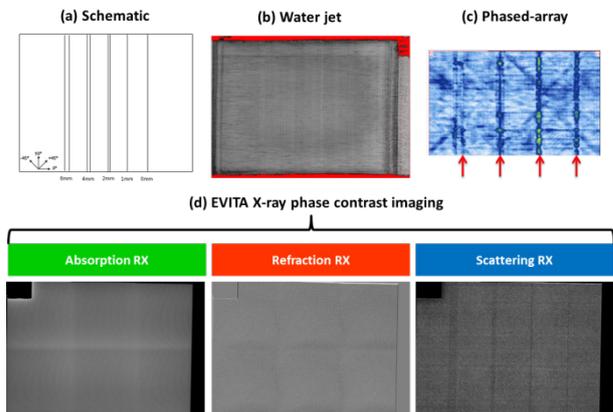
Figure 2: Results obtained on a sample with cut fibers (a) with the EVITA demonstrator (d) and with the benchmarking methods (b-c)

Figure 2 shows the results obtained with a carbon fiber reinforced polymer sample, where the mid-plane ply was cut across the width of the laminate. The artificially induced defect can be detected in the scattering image using the EVITA

demonstrator (red arrows). This result was confirmed by the measurements done with the phased array ultrasonic system.

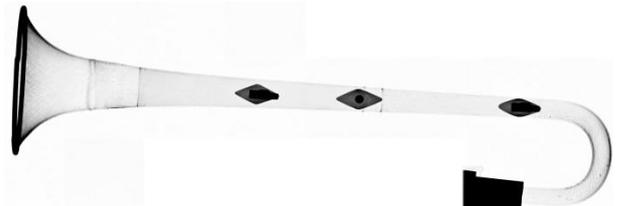
Figure 3: Scattering image of a carbon fiber reinforced trumpet bell provided by the company DaCarbo, Switzerland.

The interest is now growing in other application domains, such as for the inspection of music instruments (see Figure 3).
